Opera Assessment Report Revision 2

Independent Assessment of Eskom's Operational Situation

August 2023

Client:	National Treasury of South Africa	
Project No:	NT015/2022	
Report Title:	Opera Assessment Report – Revision 1	
Report No:	2 NT_Eskom	
Main Authors:	Bartosz Zajda (Dornier) Manswet Banka (Dornier) Klaus Bransch (Dornier) Vladan Dokic (Dornier) Pieter Janse van Rensburg (Dornier) Dr. Thomas von Schieszl (Dornier) Jörg-Schulte Trux (KWS) Ralf Wiescher (KWS) Rainer Zobel (KWS) Axel Meschbiz (RWE) Petros Terzis (RWE)	Volkmar Bobon (STEAG) Dietmar Breuer (STEAG) Dr. Ruth Egyptien (STEAG) Werner Renk (STEAG) Sener Günes (vgbe) Bernhard Michels (vgbe) Dr. Mark Newby (vgbe) Dr. Claudia Stockheim (vgbe) Dr. Oliver Then (vgbe) Dr. Christian Ullrich (vgbe) Dr. Claudia Weise (vgbe)
Date of Issue:	August 2023

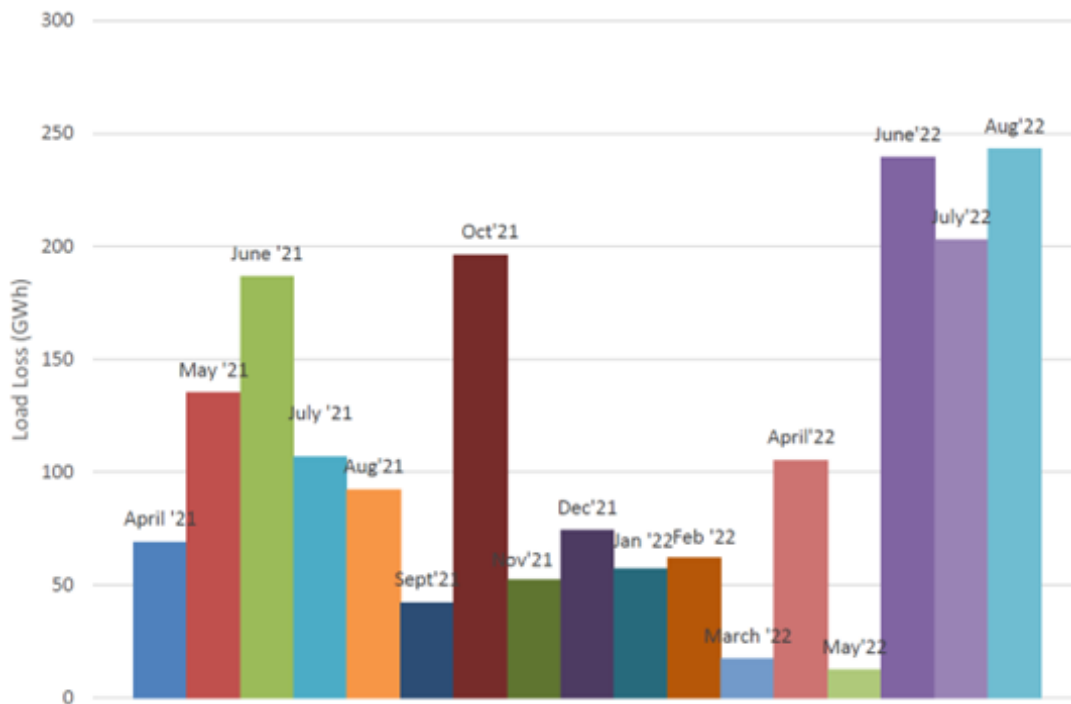
The ash handling equipment is impacting reliability and over the last 15 years its contribution to PPL has increased constantly. For example, in 2018 the ash handling system contributed 23.79 MW to PLL, while in FY2022/2023 it was 130.68 MW. In fact, over the last four years it has consistently contributed 70–130 MWs. Figure 101 and Figure 102 show the energy (GWh) and capacity (MWs) lost during 2021–2022.

Figure 101: Monthly load loss (GWh) due to ash removal constraints at Kendal Source Eskom

As the “Q3 DHP System Health Report for 2022” indicates, the ash plant has not been performing well since 2017 and is getting worse. There are problems throughout the ash handling system, resulting in outages and plant derating (lost MWs). (See photos above).

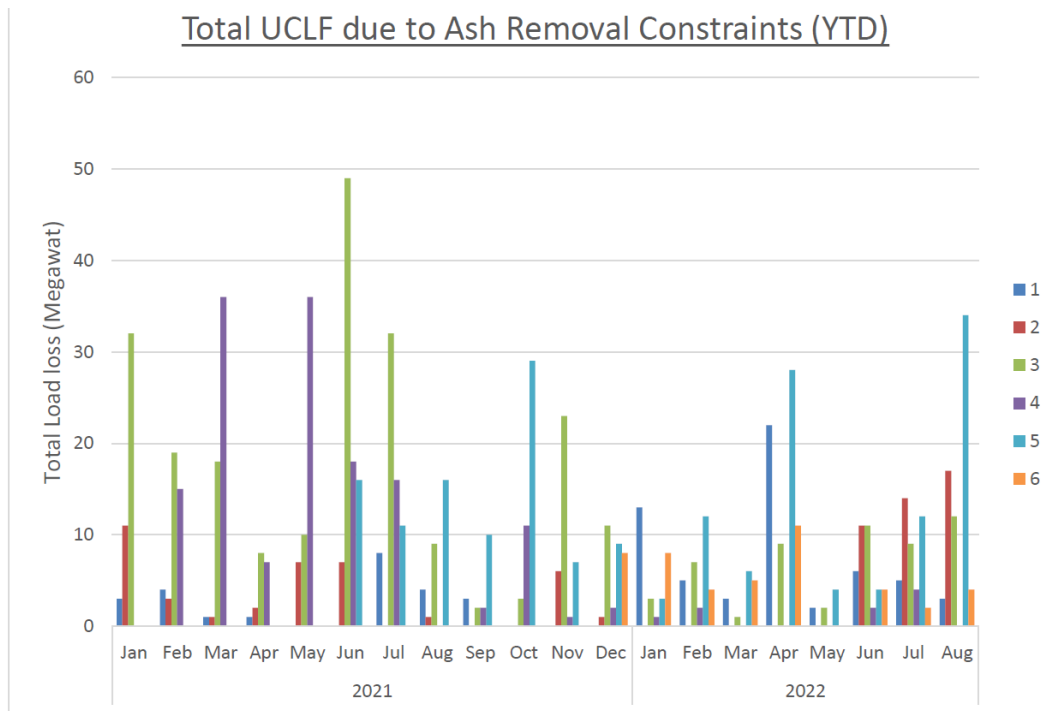
Figure 102: Monthly load loss (MW) due to ash removal constraints at Kendal Source Eskom

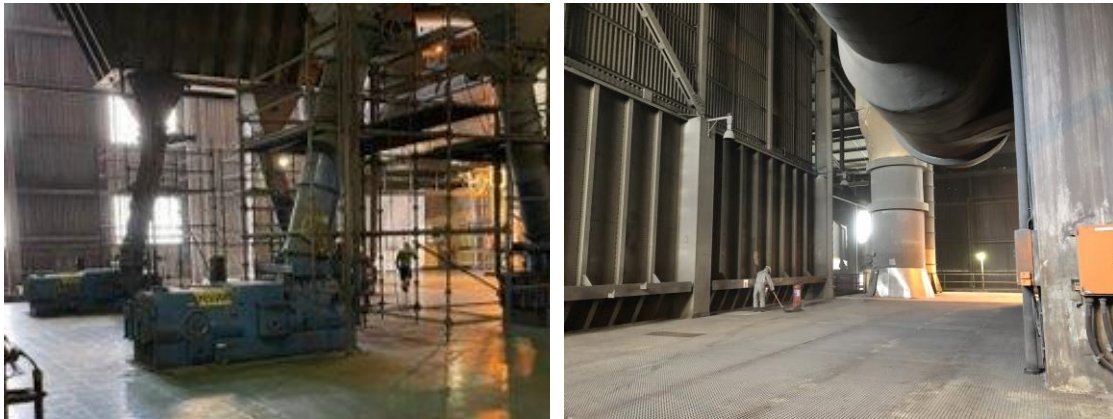
The **housekeeping** in the units seems to be reasonably good. Many employees were cleaning the boiler house while we did our site walk. The ash handling plant (wet system) is reportedly running without problems but, if there are problems, the ash is temporarily dumped on the ground. This situation appears to happen approximately once a month. The housekeeping team is advised to immediately react to such situations, which are followed up by intensive cleaning.

Figure 106: Clean boiler house at Kriel power plant

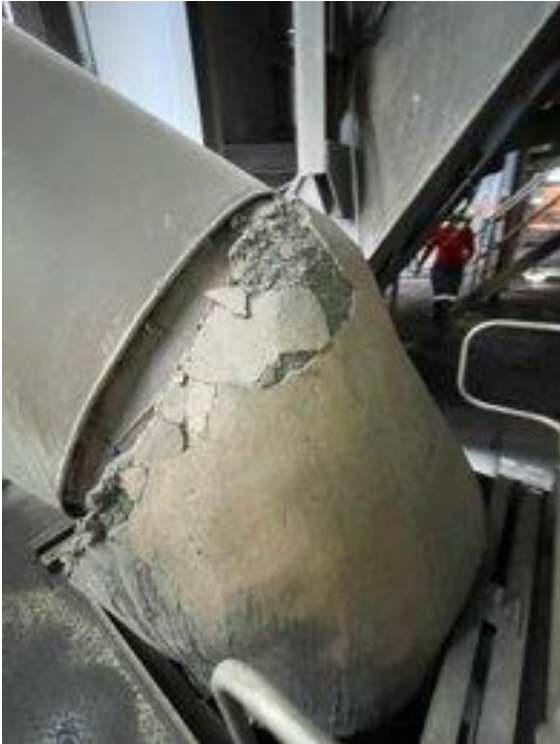
The boiler for the running units showed some signs of damage along with many steam and water leakages throughout the boiler house.

Figure 107: Example of cracked plaster insulation at a pipe in Kriel's boiler house

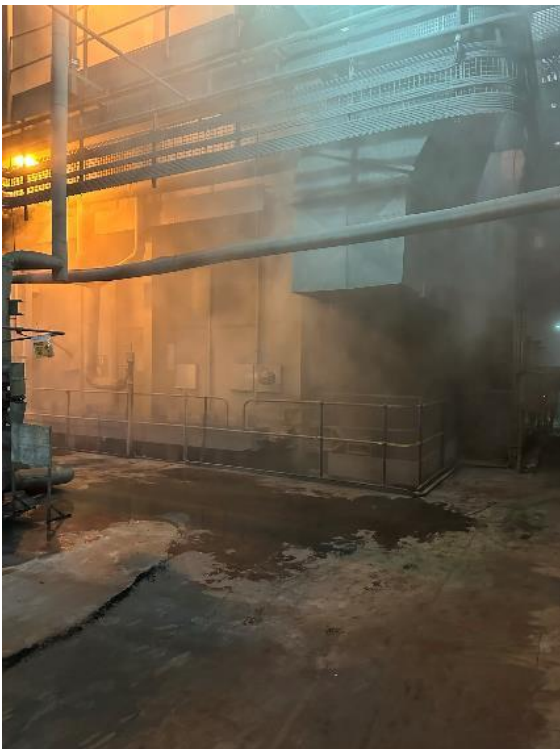
Figure 108: Water and steam leakages in Kriel's boiler house

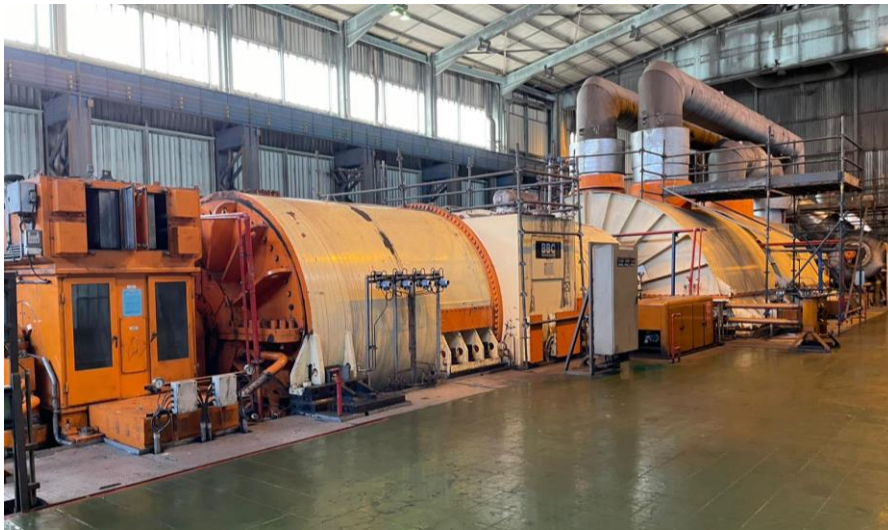
The housekeeping in the **turbine** area is acceptable. However, some parts of the turbine are not completely insulated. Moreover, there are vibration issues at the turbine plant that are linked to an improper maintenance of turbine oil systems resulting in malfunction of oil system. Specific reasons of the vibrations cannot be evaluated precisely. Nevertheless, on site we were told that oil drains were clogged and may disturbed oil circulation. Another possible root cause could be foreign contaminations of oil during refilling and/or maintenance work in the oil station. In this regard it is very likely that additionally some equipment failure e.g. of jacking oil system also contributed to turbine bearings vibrations. Usually the turbine oil systems (jacking oil, lube oil, hydraulic oil) are serviced from one common oil handling plant.

Figure 110: Clean turbine area at Kriell

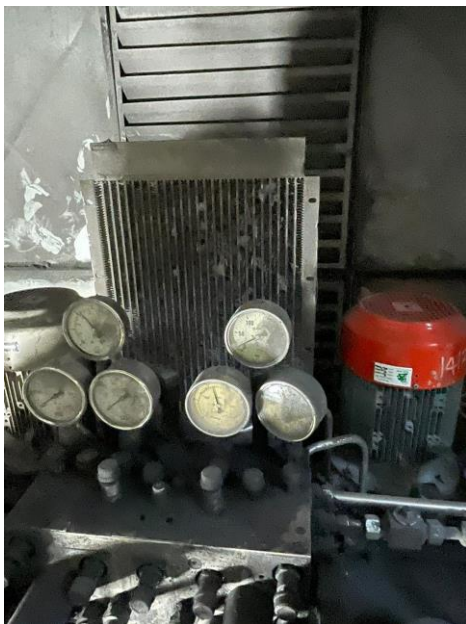
Figure 111: Oil station at Kriell's HP bypass

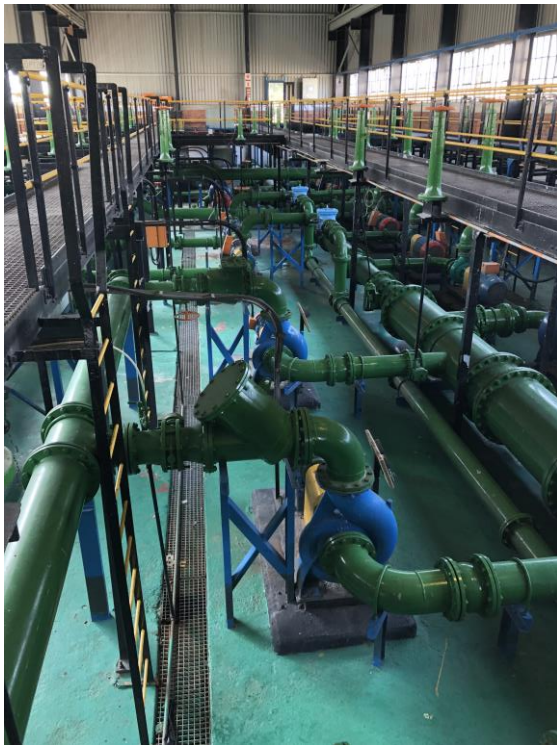
The regeneration of the anion and cation exchanger is carried out with sulfuric acid caustic soda. During the site visit, the team learnt that neutralisation of the regeneration effluents is not carried out. The effluents are discharged into the plant's channel system without any

treatment. This poses a high risk of damage to pumps and foundations (sulphates can badly damage/erode concrete). This risk remains, even if channels are lined, except if there is a regular and consistent check of their state.

Figure 113: Water treatment plant at Kriel

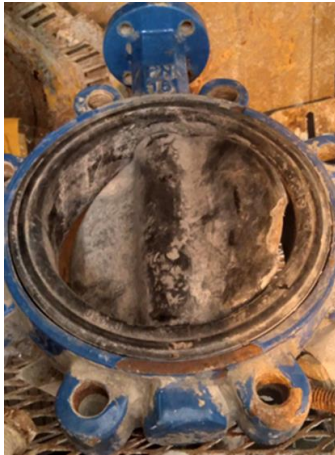
Eskom claims that boiler design issues³¹ are leading to high spray water requirement, high boiler end temperature and issues on PJFF and FGD performance. Below pictures show the frequent failure of FGD equipment in Units 1, 2 and 3.

Figure 118: Butterfly valve rubber liner damaged at Kusile

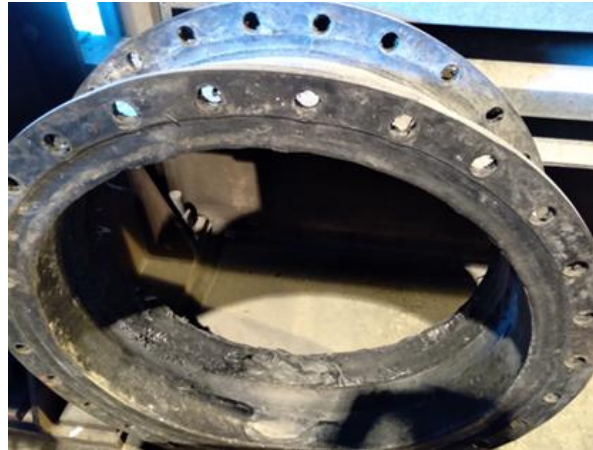
Figure 119: Damaged rubber liner at Kusile

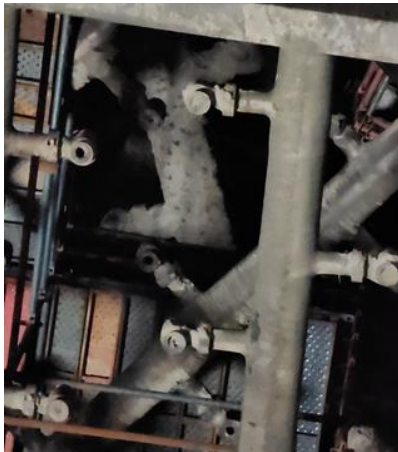
Figure 120: Choked spray nozzle at Kusile

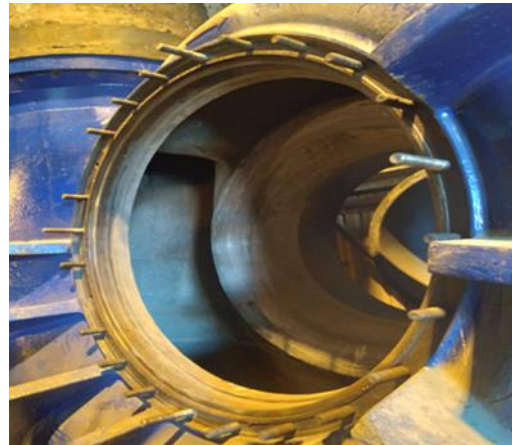
Figure 121: Pump liner failure at Kusile

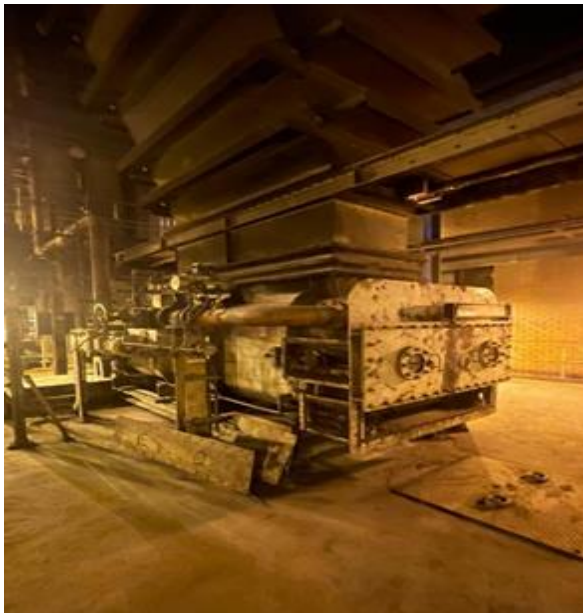
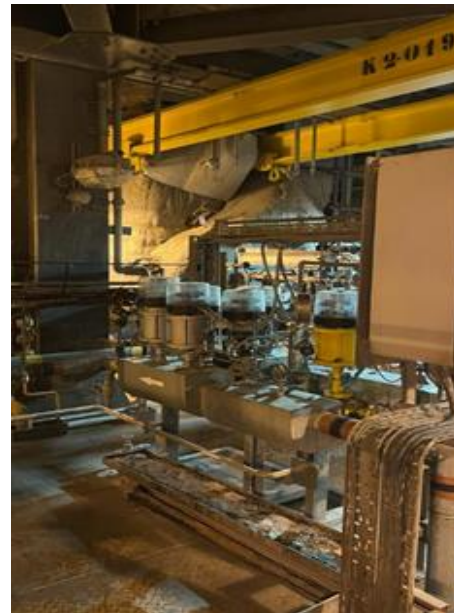
Figure 122: Poor housekeeping at Kusile

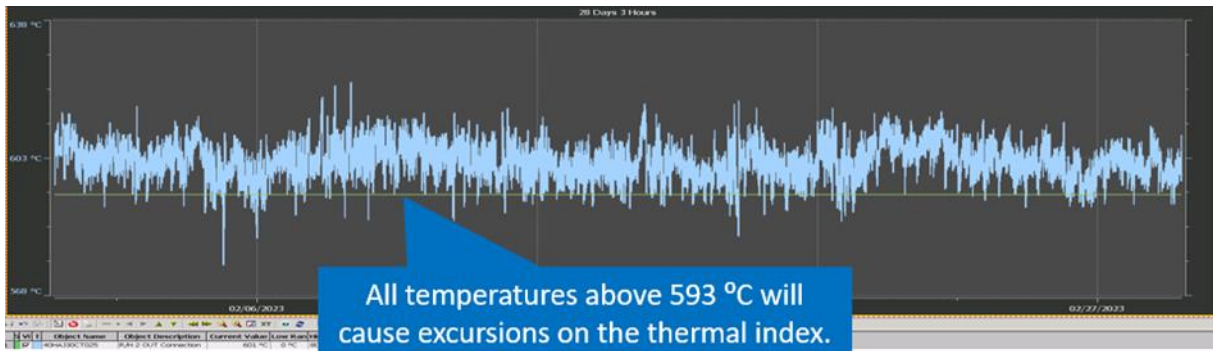
Figure 123: Exceeding Thermal Index at Kusile

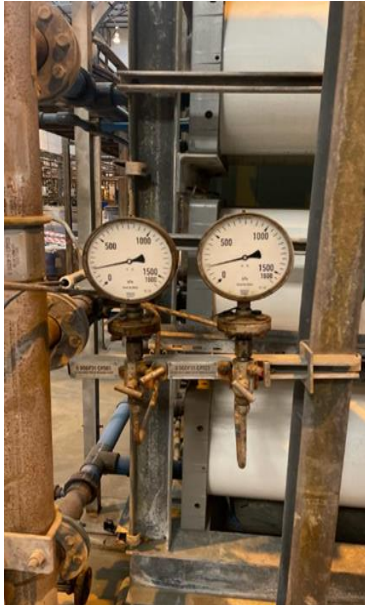
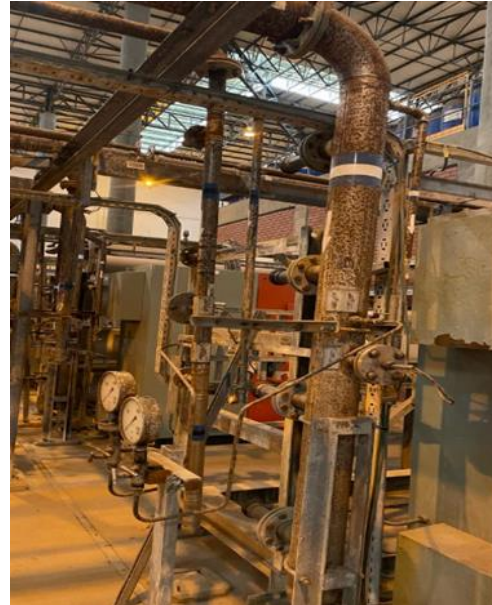
Figure 124: Bad condition of Kusile's water treatment plant

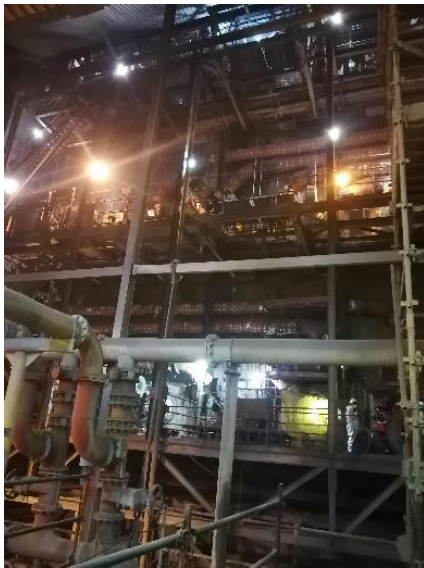
During the visit, the team walked through the **boiler house**. In general, the housekeeping was in order. There was no high amount of dust, and no visible leakages or safety-related issues were observed.

Figure 132: Lethabo's Unit 6 boiler house

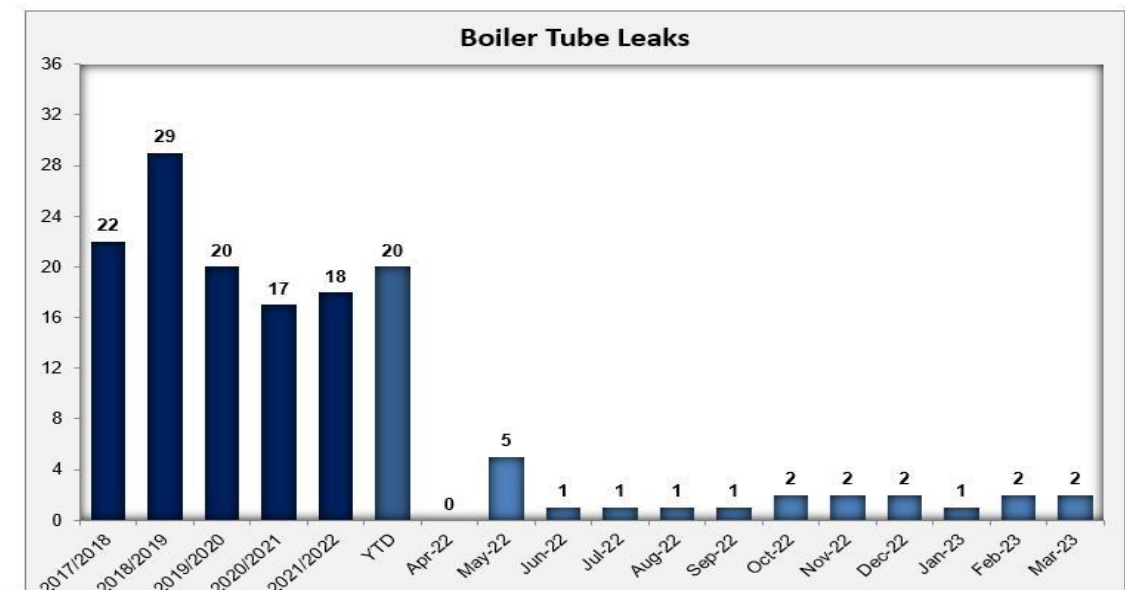
The overall generation availability of the station has fallen due to frequent BTF (20 in FY2023, see Figure 133), affecting both station reliability and output. The boiler tube mid-life refurbishment programme was deferred from FY2010, and it is still uncertain when it will take place. There is a current backlog of boiler tube maintenance and this, as well as boiler tube spares not being available, has resulted in tube replacements not being completely carried out during outages. The current lead time for boiler tubes is 5 months. Budget approval, procurement of spares and completion of the full scope of work are essential. The current situation poses a paramount risk to station performance.

Figure 133: Lethabo's BTL per year and month
Source Eskom

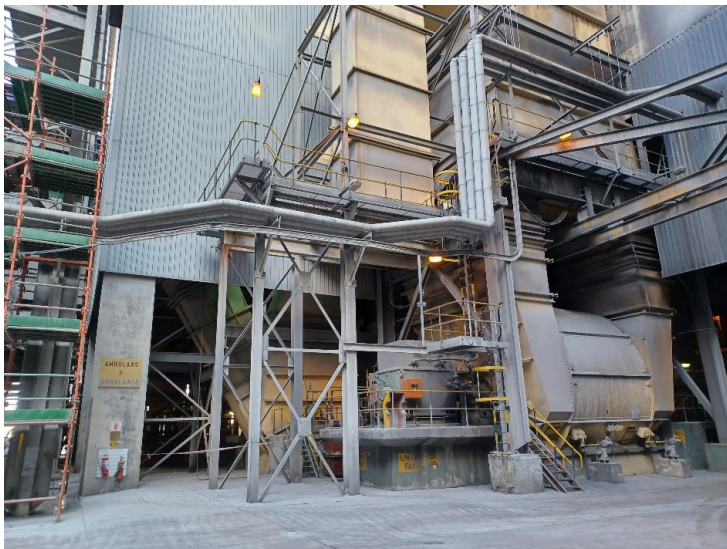
Figure 134: Lethabo ID fan Unit 1

The draft system is not operating at maximum capacity. The operating issues are mostly related to the ID fans, which are affected by increased erosion due to increased dust loading (at the exit of the ESP). Also, thinning of the ID fan blades has been reported, which requires urgent attention.

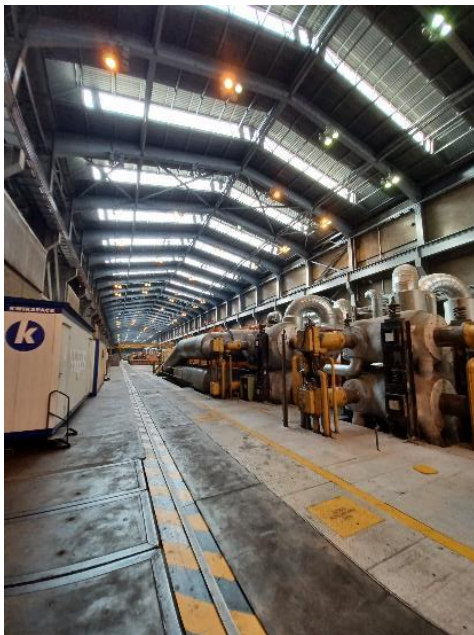
Figure 136: Turbine hall at Lethabo power plant

Turbines are MAN impulse-type HP, IP and reaction-type double flow LP, triple-casing condensing turbines have been installed. The turbine hall is reasonably clean. Dust is present on all equipment, but it is not as bad as at some of the other stations we visited. As can be seen in Figure 131, turbines represented only 6.1% of UCLF in FY2023 and are well maintained and generally in good condition.

Lethabo power station has been running continuously for more than 30 years, and the turbines have already reached their designed mid-life operating age with 300 000 operating hours. To extend their life to 350 000 operating hours, it will need a general overhaul with parts replacement.

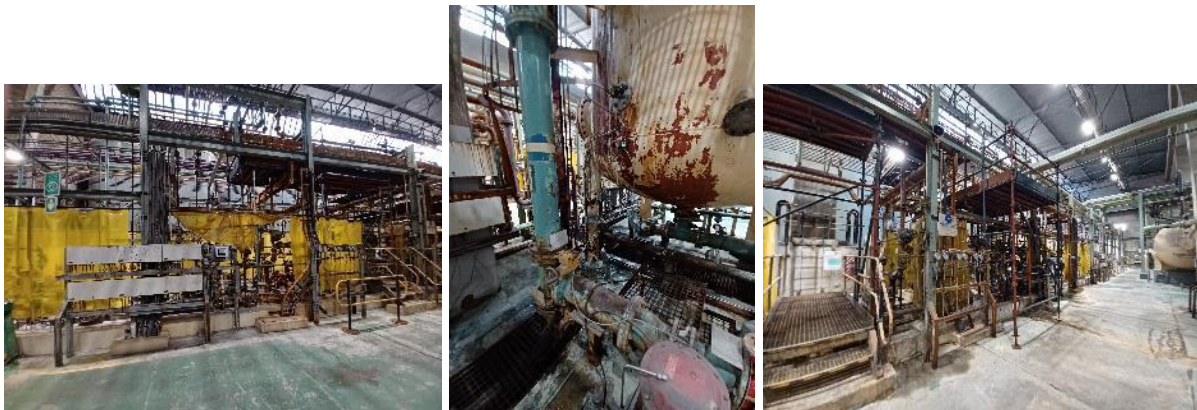
Figure 137: Lethabo's water treatment plant in May 2023

Lethabo power station obtains raw water directly from the Vaal river and consumption is 120 ML/day. The water treatment plant did not cause any problems until last year when its performance started deteriorating; urgent refurbishment is needed. In the past, designed capacity of the demineralised water plant was sufficient for stable and failure-free operation of the power station, especially the boiler plant. Now, its performance is too poor to supply the plant because of high water and steam leakages and system failures.

- The capacity of the demineralised water plant is not sufficient, mainly caused by losses due to steam and water leakages at the plant.
- There is an urgent need for refurbishment of the whole plant.

Upgrading of the water treatment plant DCS system is also required.

In addition to refurbishment, serious efforts are needed to reduce water consumption. It will have to be reduced significantly to be able to run the power plant with one water treatment train; alternatively, a temporary mobile plant would be required.

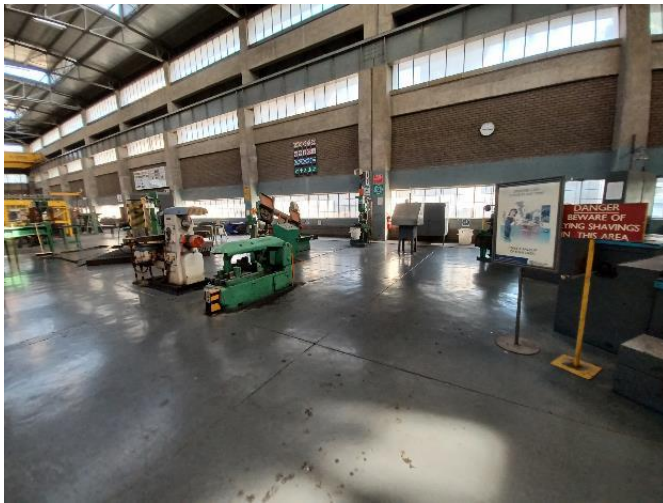
Figure 138: Lethabo warehouse

The spare parts warehouse and maintenance workshop were also visited. The workshop is clean but its scope with regards to repair work is limited (see Figure 138). It has limited capacity and most of the repair work needs to be outsourced.

Also, there is a shortage of spare parts due to budget constraints. Some critical and operational spare parts are not available in stock. Late approval of outage budgets means that spares are being procured during outages. This is completely unacceptable practice, because it is a cause of outage slip that is a big problem in general.

We recommend the development of a strategic warehouse with security fencing and camera surveillance.

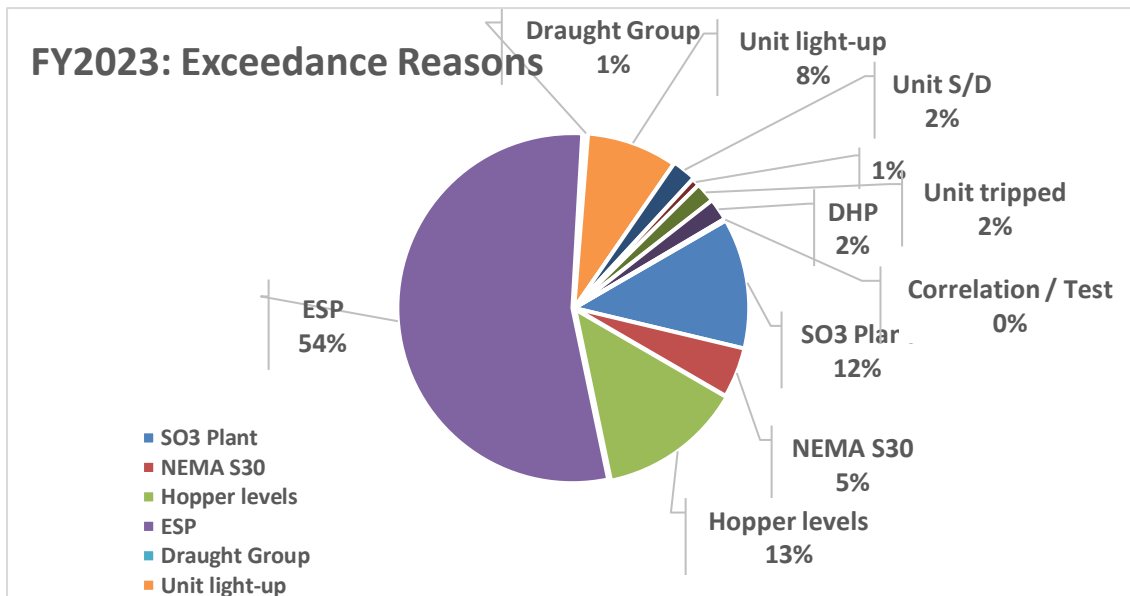
Figure 139: Emissions exceedance reasons at Lethabo
Source Eskom

Lethabo power station has been treated leniently with regards to environmental compliance. The plant does not comply with PM requirements. Presently, the required limit is 100 mg/Nm^3 and the plant emits more than 100 mg/Nm^3 . Steps are being taken (a high frequency transformer project is in progress – Units 1 and 6), but a comprehensive upgrade of all the ESPs is needed. The emissions exceedance reasons for PLL for high stack emissions in FY2023 are presented in Figure 139, below:

The station needs to install low NO_x burners to reduce NO_x from the present level of 1 000–1 200mg/Nm³ below the future limit (750 mg/Nm³).

- ESP upgrading is urgently needed, both to comply with 50 mg/Nm³ (by 2025) and to improve ID fan performance.
- SO₃ plant needs an upgrade.
- The plant needs to lower NO_x emissions by 2025; low NO_x burners seem to be the preliminary option of choice.
- Lethabo needs to assess how it will comply with SO₂ control requirements (1 000 mg/Nm³, which comes into effect in April 2025). Alternative options (lower sulphur coal and SO₂ control technologies) need to be evaluated.

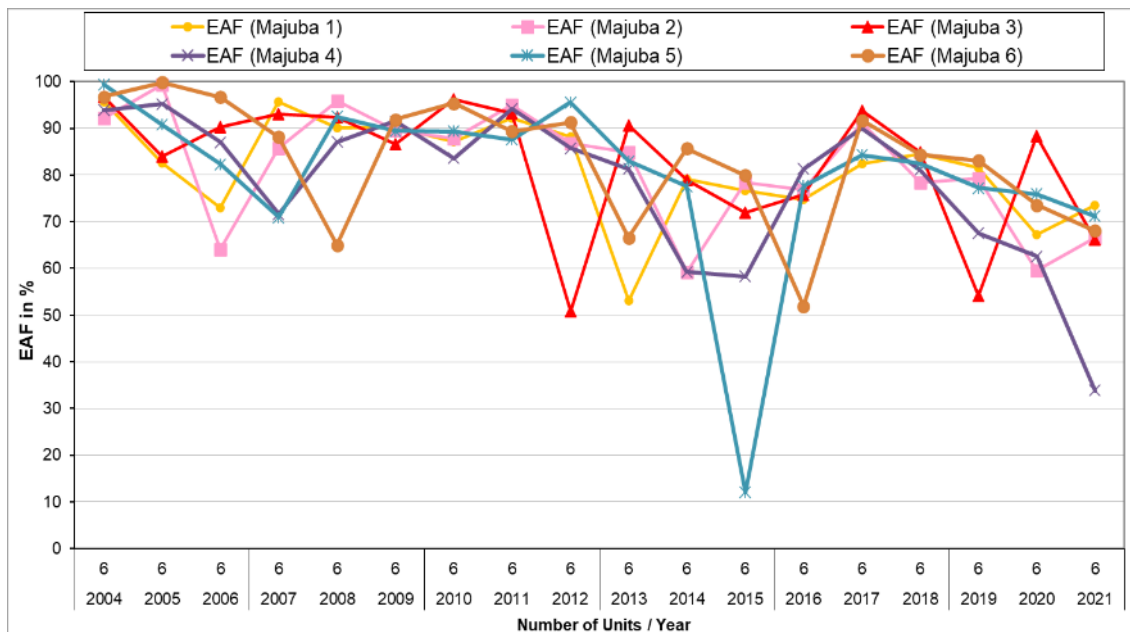
Figure 140: EAF of Majuba power plant (FY2003/2004–FY2020/2021)

In the years 2017 to 2021, the EAF of the total power plant was between 88.45% (2017) and 62.55% (2021). During this period, fluctuations in EAF increased (see Figure 140) and there was an almost steady decrease in total EAF through to 2022, when EAF for the plant as a whole fell to 47.95% (see Table 64). Recent steps, undertaken to improve the plant's EAF again, lead it to rise to 63.03% in FY2023.

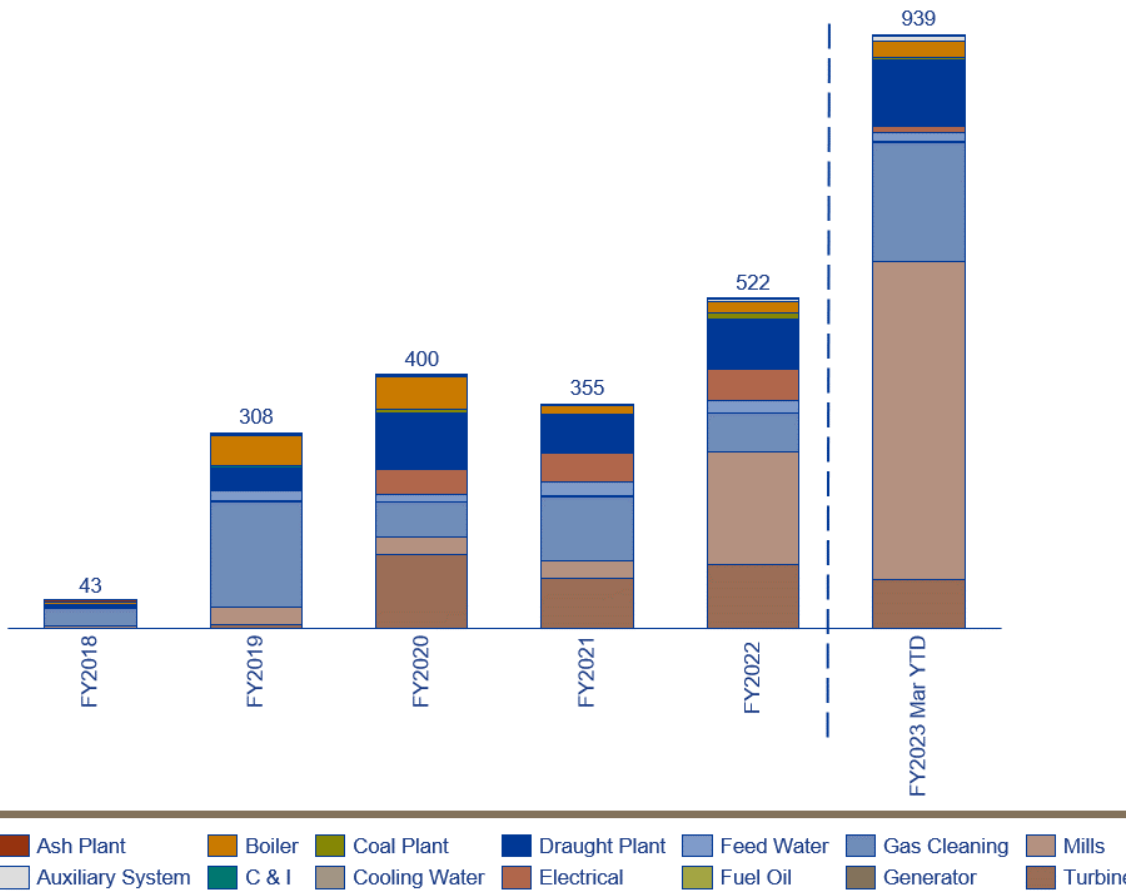
Figure 141: PLL contributors at Majuba power plant (FY2017/2018 to 3/2023)
Source: Eskom

The main reason for the low EAF has been the significant PLL, accounting for approximately 61% of the total unplanned capacity loss factor (UCLF). The main sources of PLL are depicted in Figure 141. As can be seen, an array of components influences PLL – the main components are the mills (54%), the gas cleaning (20%), the draught plant (11%), the turbine (8%) and the boiler (3%). The PLL for the individual components has fluctuated over the years but increased steadily in the period FY2018-2020, with a slight improvement in FY2021. In FY2022, there was a sharp increase of approximately 47%. At the beginning of FY2023, there was a significant increase in PLL, to 78% of total load losses, caused by a dramatic increase in losses at the milling plant, which had had almost no negative impact on the system up until FY2021.

The PLL values given by Eskom, together with the figures provided for the contributing factors, are in stark contrast to those given by the power plant general manager on 20 April 2023. This deviation between the data given by Eskom (see Figure 141 and Table 65) and the numbers provided during the site visit can partially be explained by mill repairs carried out over the last few months and by increasing wear and tear on the filter bags. But, overall, many factors have played a part and, for the time being, cannot be clearly identified.

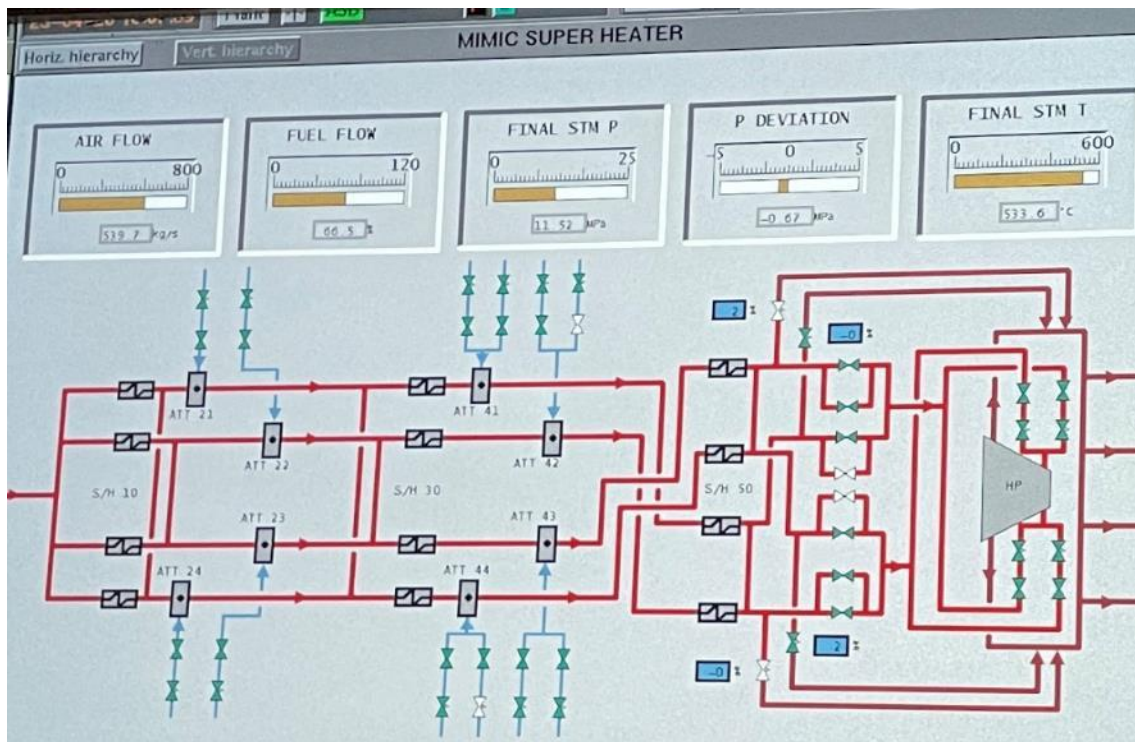
Figure 143: Steam conditions – air flow and fuel flow at Majuba power plant

Steam temperatures: The steam temperatures at the boiler outlet are in line with the design, as a result around, 535°C (see Figure 143). No significant temperature differential between the different sides of the boiler could be observed.

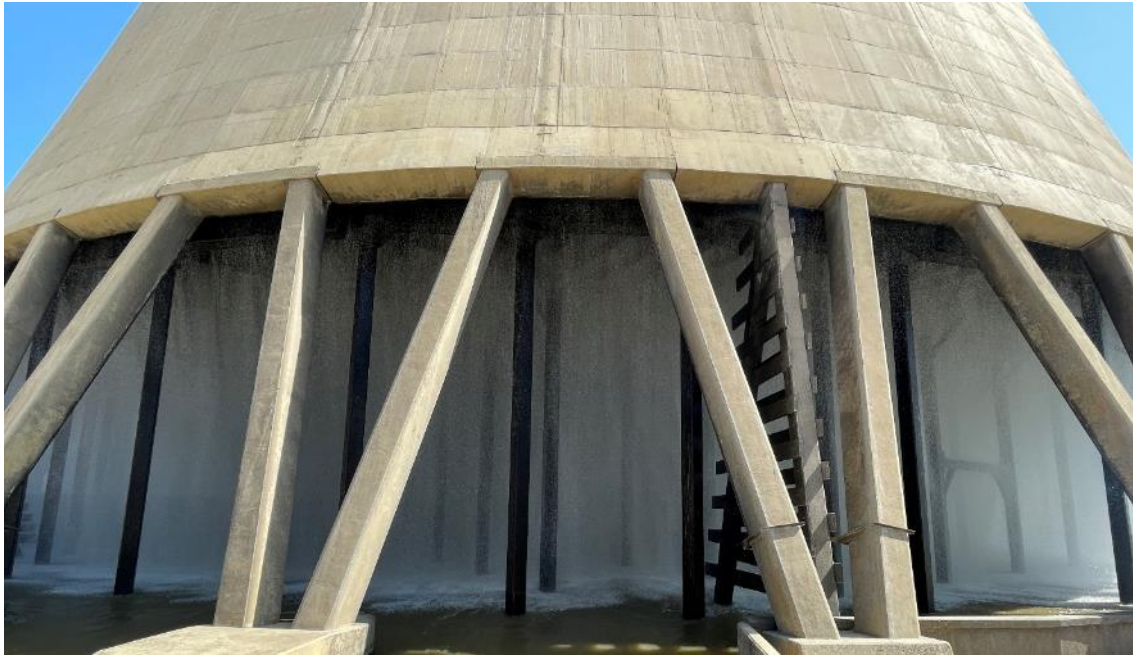
Cooling towers: The cooling towers of units 4 to 6 are in good condition, not showing signs of biofouling or missing or damaged end caps as far as visible. The spray pattern was as expected (see Figure 146). Based on our assessment, the cooling towers are not expected to negatively impact power plant operations or lead to reduced power output. However, it should be noted that the plant was running at partial load at the time of our visit.

Figure 146: Majuba cooling towers without biofouling and with a proper spray pattern

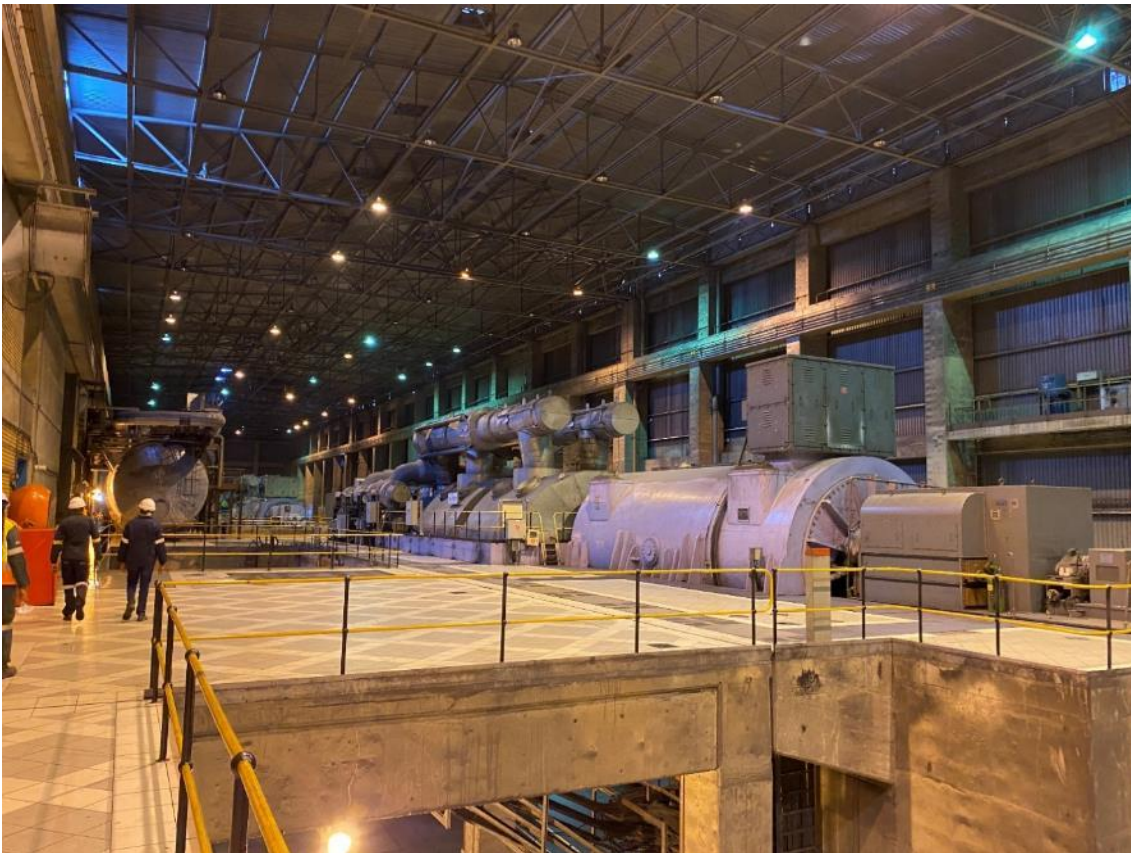
Figure 149: Reasonably clean turbine hall at Majuba power plant

Turbine: First of all, the turbine hall was reasonably clean, as the housekeeping was conducted well (see Figure 149). The overall condition of the turbines was good, with only a few negative occurrences limiting the power production in the past. According to Eskom staff, the only notable influence was given by the turbine drive train of Unit 6, which caused a power loss of 17 MW_e, and sound problems at Unit 4, which caused a power loss of 78 MW_e. The power losses on Unit 6 are mainly driven by an inefficient steam flow through the HP turbine, due to deposits on the turbine blading. The reason for the deposits couldn't be investigated during engine operation. Water quality does not seem to be the source of the problem because no other engines and parts are affected. On some units, slight traces of coked oil were noted on the bearing pedestals and on the lower turbine casings. This was probably caused by small oil leakages or oil dust, which can be largely considered as normal, given the age of the plant. The turbines were operating within the norm. Online vibration monitoring, bearing temperatures and steam parameters were within design range. No obvious leakages could be identified at the on-site inspection.

However, the spare-part handling for an upcoming turbine overhaul was sloppy. Stop and control valves that had already been refurbished and were awaiting use in the overhaul were lying unprotected in the turbine hall, exposed to dirt, dust and foreign particles, which were also found in the replacement valves.

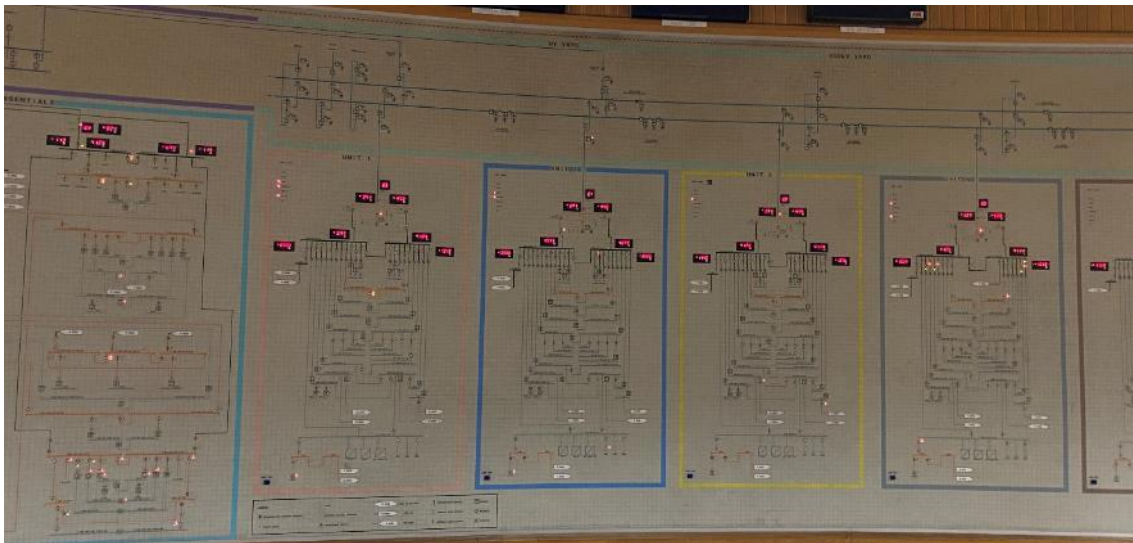
C&I system: The C&I system at all units and the outside plant are outdated and thus require refurbishment. The HMI mosaic panel is not up to date, either, and needs to be upgraded (see Figure 150).

Figure 150: Obsolete HMI mosaic panels at Majuba power plant

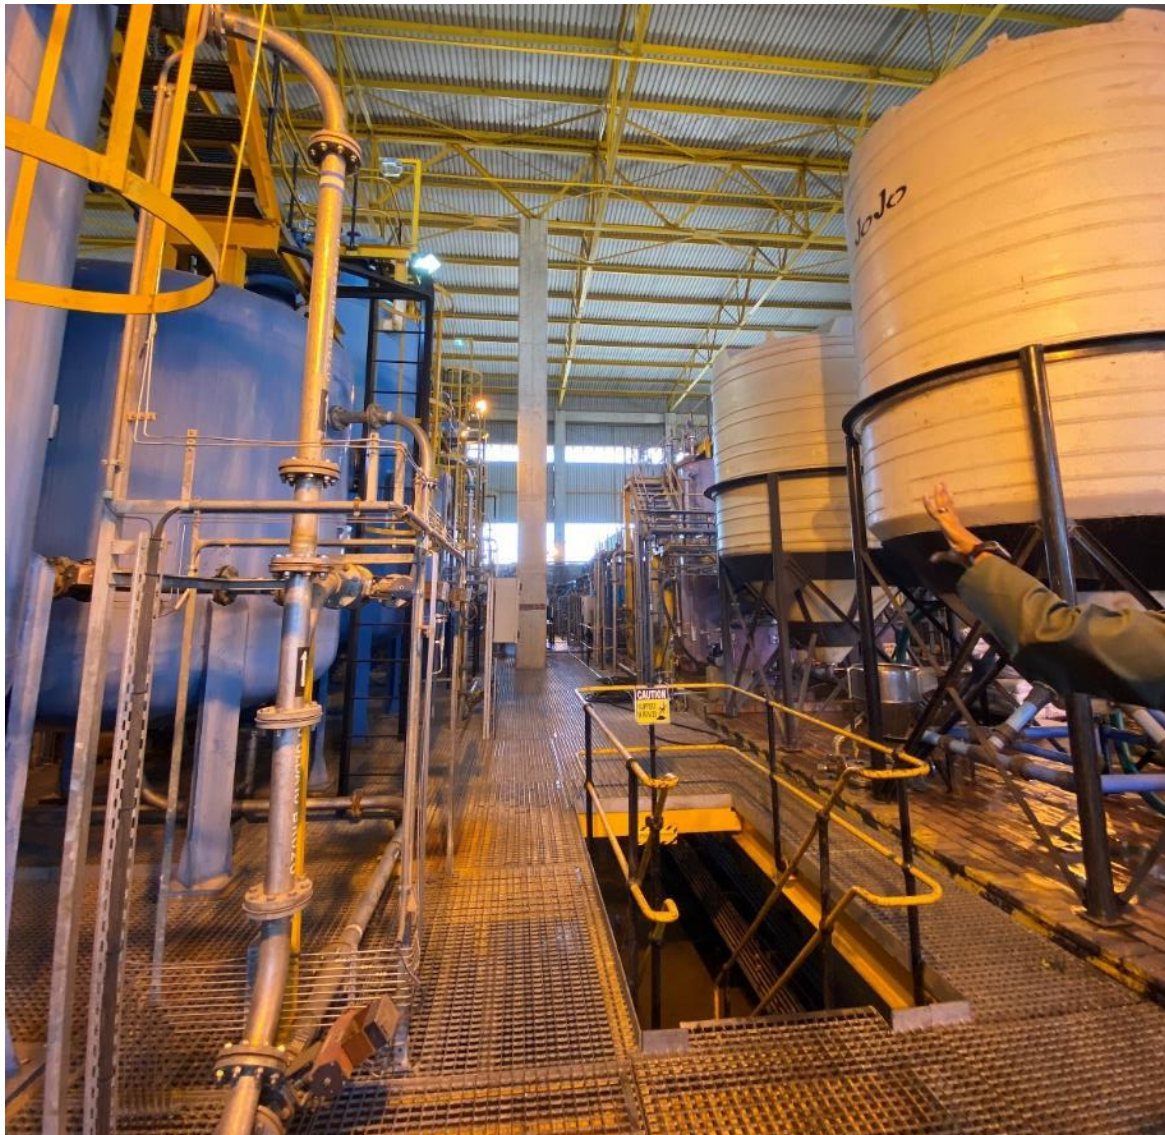
Figure 152: Water treatment plant at Majuba power plant

Make-up water plant: The central make-up water plant was visited during the site walk. The building of the water treatment plant was clean and, all in all, in order (see Figure 152). The capacity of the make-up water plant is sufficient to cover the the site's needs with water of sufficient quality.

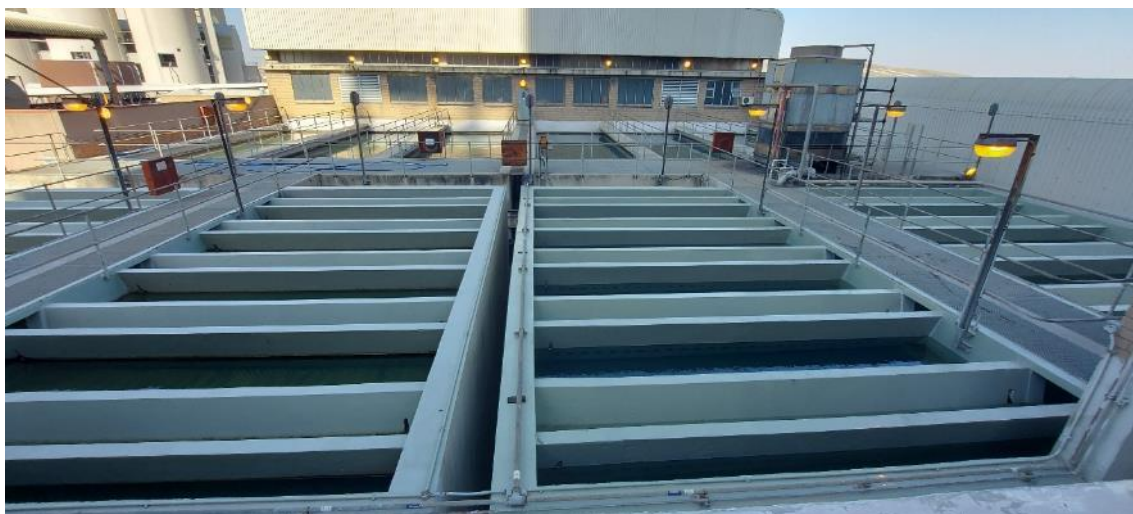
Filters: The water filters are in good condition as well, not showing major signs of aging and working as intended.

Figure 153: Sand filters at the water treatment plant at Majuba power plant

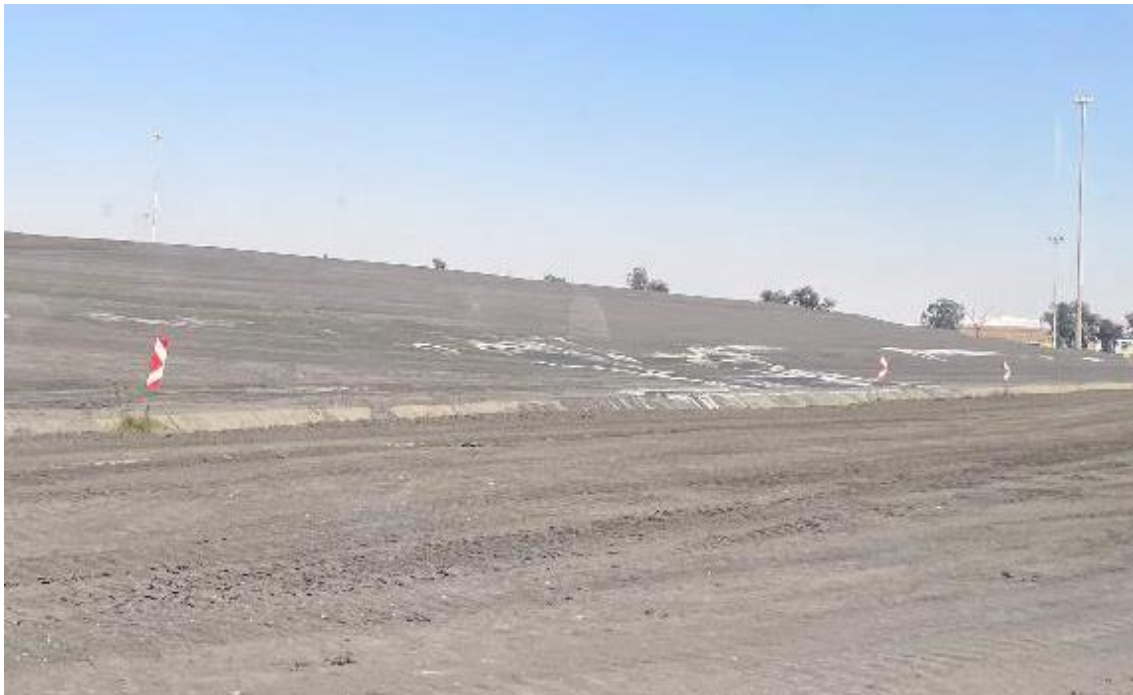
Figure 154: Stockpile at Majuba power plant

not possible to avoid problematic coal segments or blend them properly to reduce the negative impact, even though the coal stockpile is well managed and in order (see Figure 154).

Coal handling site: The coal handling site is generally well managed but too small to stockpile enough coal to enable it to postpone using the coal until it has been analysed (see Figure 154).

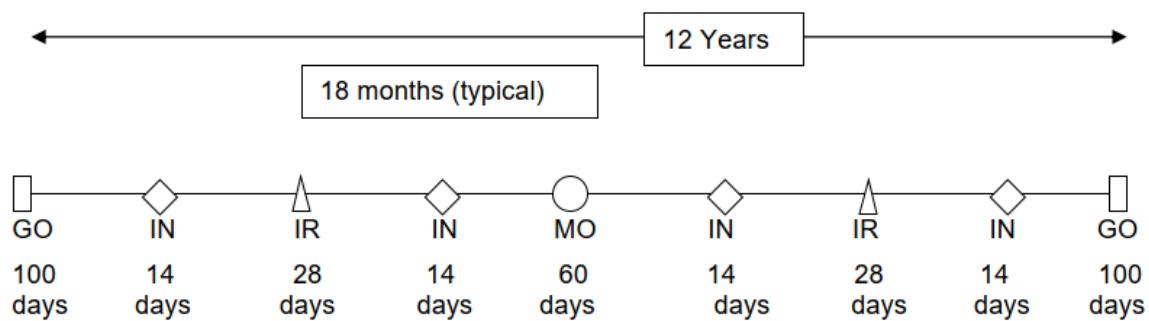
Figure 155: Outage sequence at Majuba power plant
Source: Eskom

Figure 155 shows Majuba power plant's modified outage plan. The addition of the so-called interim repairs (IR) was necessary to refurbish the fabric filter systems within the units. Due to a lack of procurement and/or financing, a lack of filter bag fabric caused an IR delay, which was one of the main reasons for the high PLL notable at the power plant at the time.

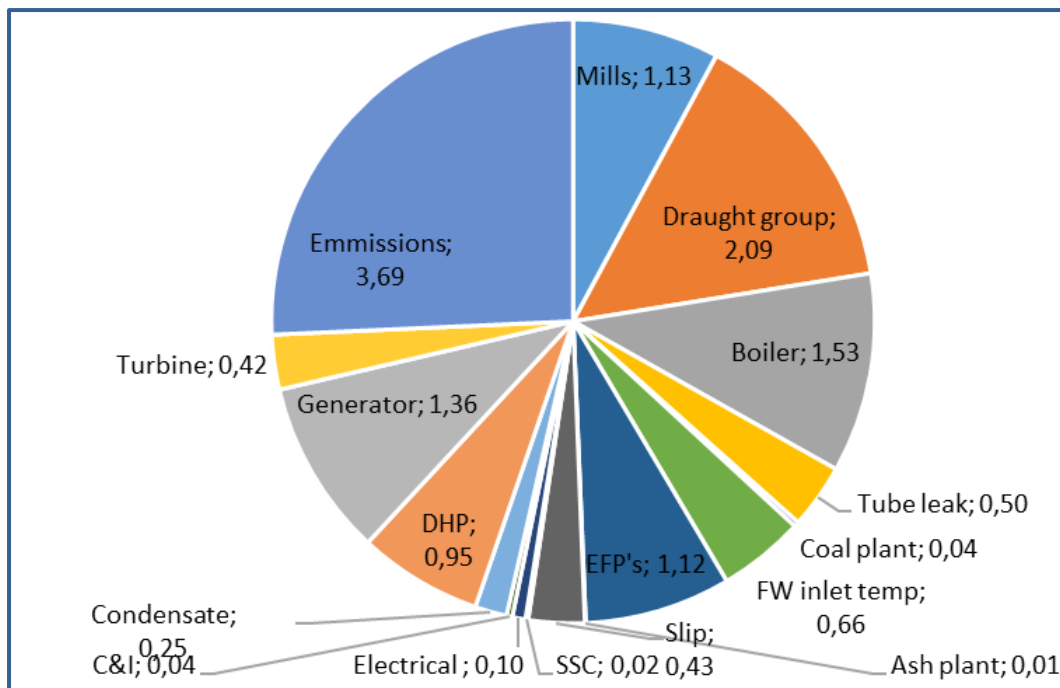
Figure 156: Matimba UCLF breakdown for FY2022/2023

From 2020 onwards, plant performance has deteriorated and UCLF increased to 14% during the last financial year, which is too high. The breakdown of FY2022/2023 UCLF is shown in Figure 156.
